# **INDOOR AIR QUALITY ASSESSMENT**

**Milford District Court  
161 West Street  
Milford, Massachusetts**

Prepared by:  
Massachusetts Department of Public Health  
Bureau of Environmental Health  
Indoor Air Quality Program  
February 2008

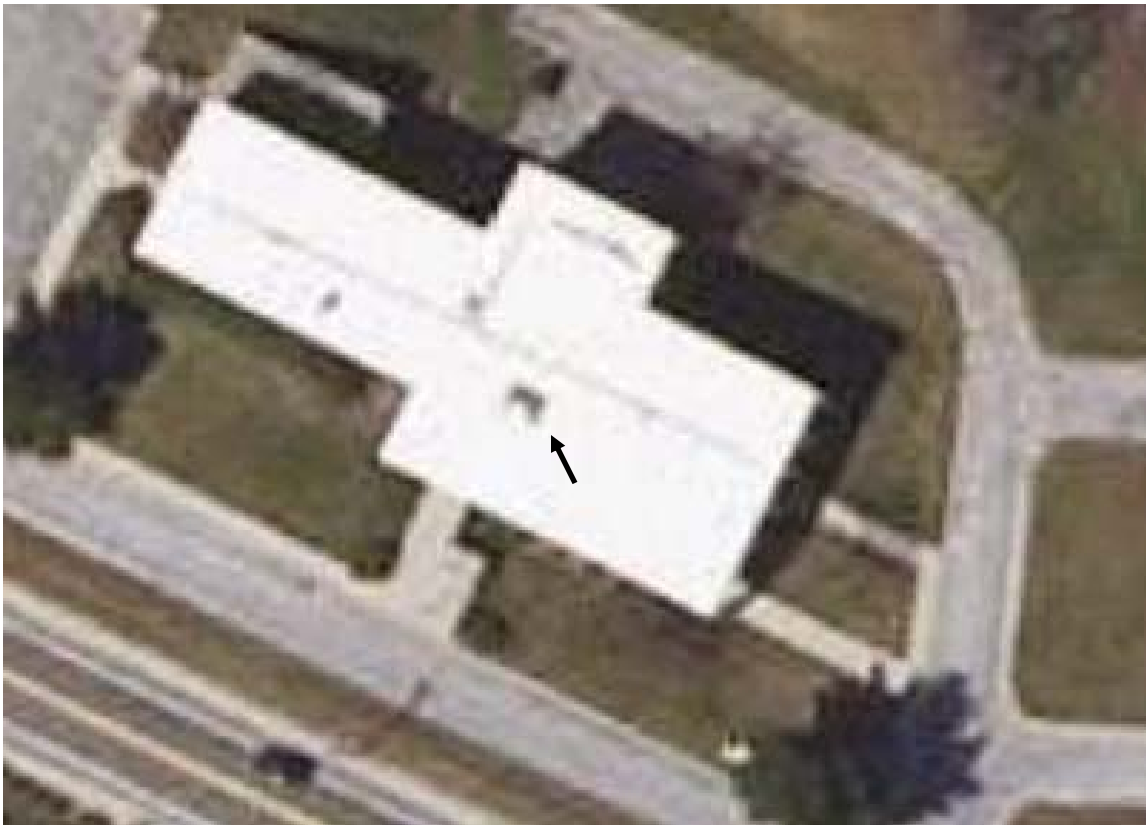
**Picture 1**

Mechanical ventilation in the court rooms, main lobby/security checkpoint area and interior rooms is provided by air-handling units (AHUs) located either on the roof (Picture 1) or in the first floor mechanical room (Picture 2). Conditioned air is distributed via slotted or multi-directional air diffusers (Pictures 3 through 6) and ducted back to AHUs via return vents (Pictures 7 and 8). As previously mentioned, the mechanical systems were deactivated; therefore there was no means of mechanical air exchange during the assessment, as evidenced by elevated carbon dioxide levels (e.g. 3,041 ppm in courtroom #1). Without proper supply and exhaust ventilation, normally occurring environmental pollutants can build up indoors and lead to IAQ/comfort complaints. The system was subsequently reactivated by MDC maintenance staff, which reduced the carbon dioxide level substantially (1,360 ppm/Table 1).

**Rooftop AHU for Main Lobby/Security Checkpoint Area**

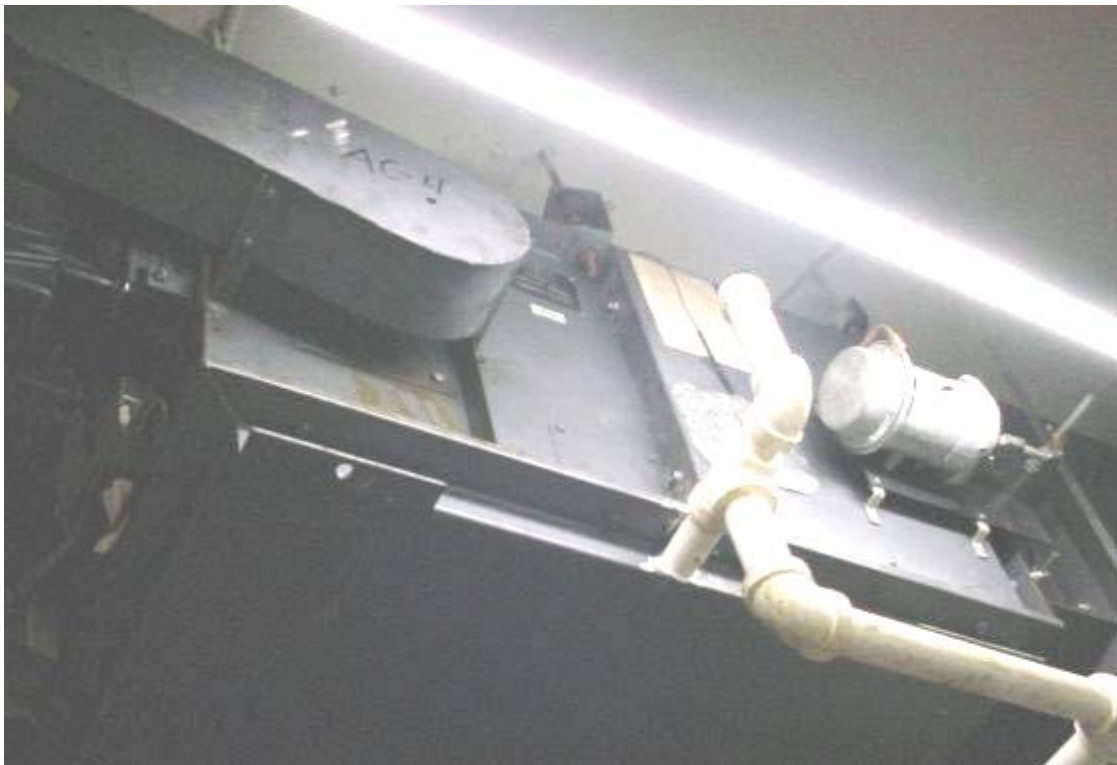
**Picture 2**

**AHU located in First Floor Mechanical Room**

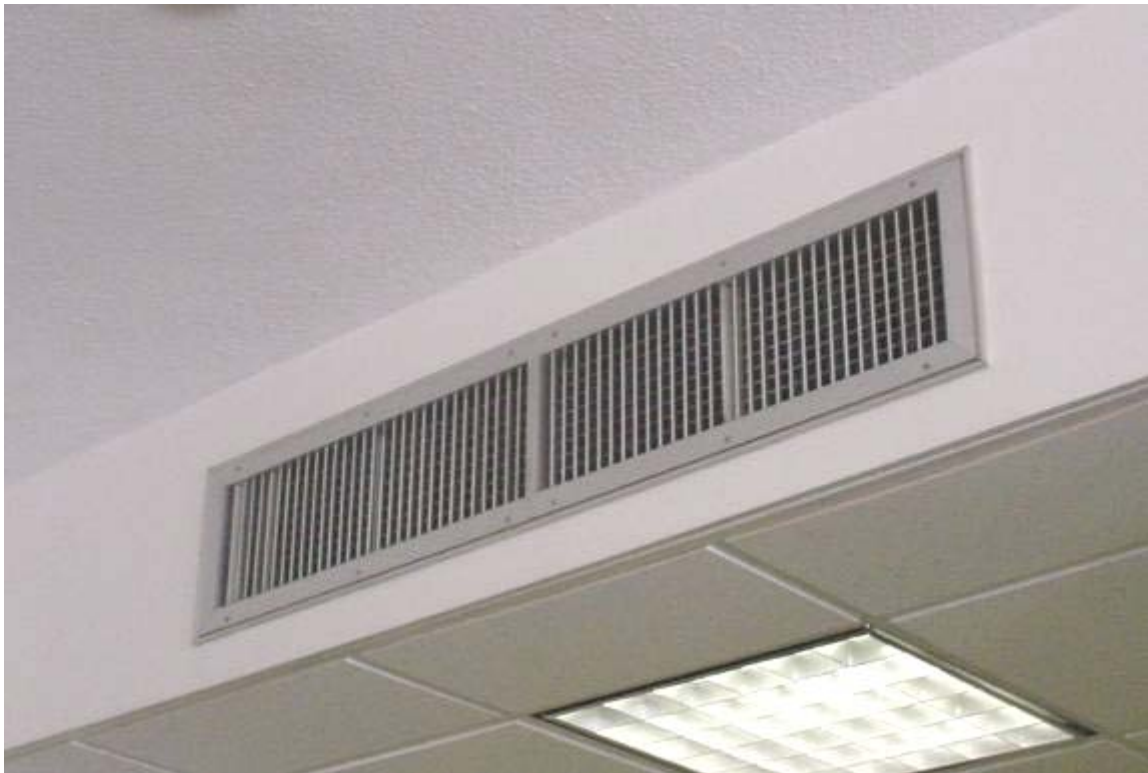
**Picture 3**

**Supply Diffuser in Main Lobby/Security Checkpoint Area**

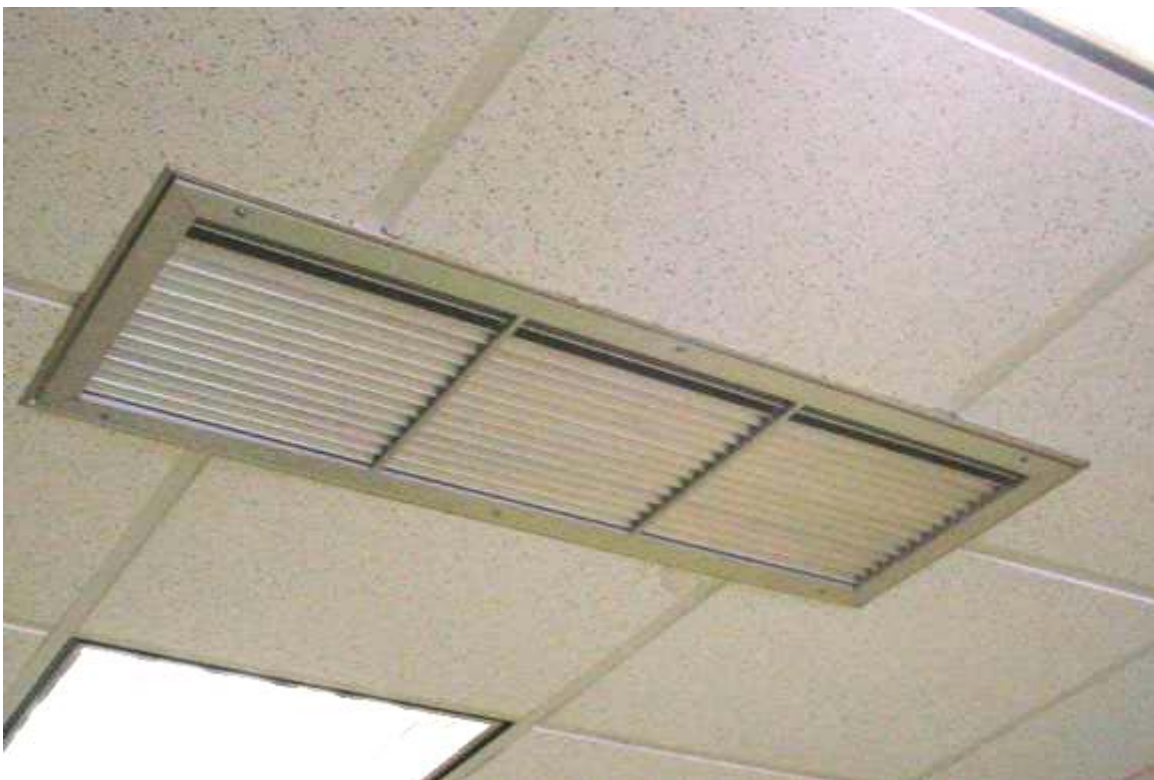
**Picture 4**

**Return Vent in Main Lobby/Security Checkpoint Area**

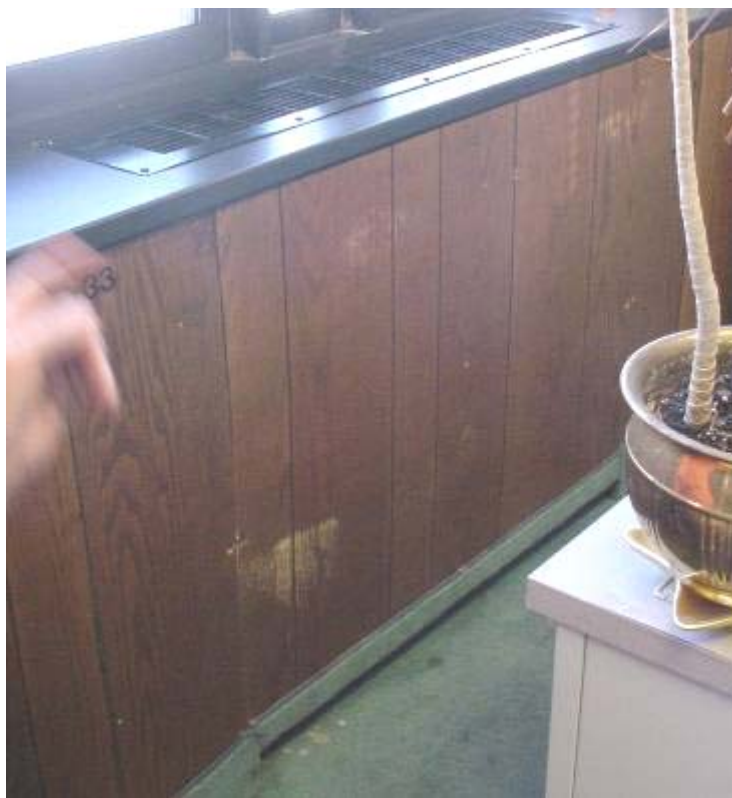
**Picture 9**

Fresh air in office areas is provided by (univent) systems (Pictures 9 and 10). A univent draws air from outdoors through a fresh air intake located on the exterior wall of the building (Picture 11) and returns air through an air intake located at the base of the unit (Picture 12). Fresh and return air are mixed, filtered, heated and provided to classrooms through an air

Univents are reportedly original equipment (40+ years old). Efficient function of such aged equipment is difficult to maintain, since compatible replacement parts are often unavailable.

**Original 1960s Vintage Univent Built into Cabinet**

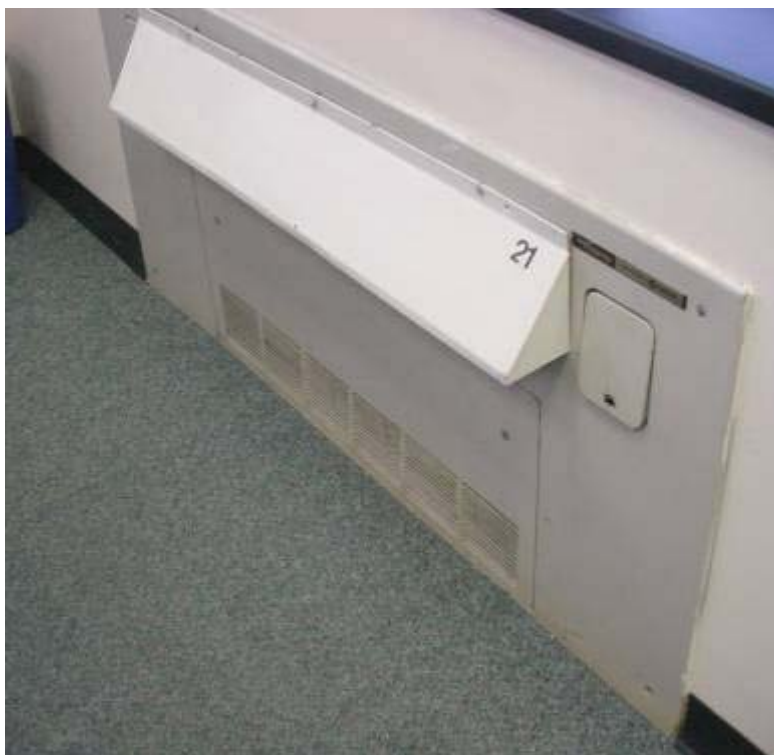
**Picture 10**

**Original 1960s Vintage Free-Standing Univent**

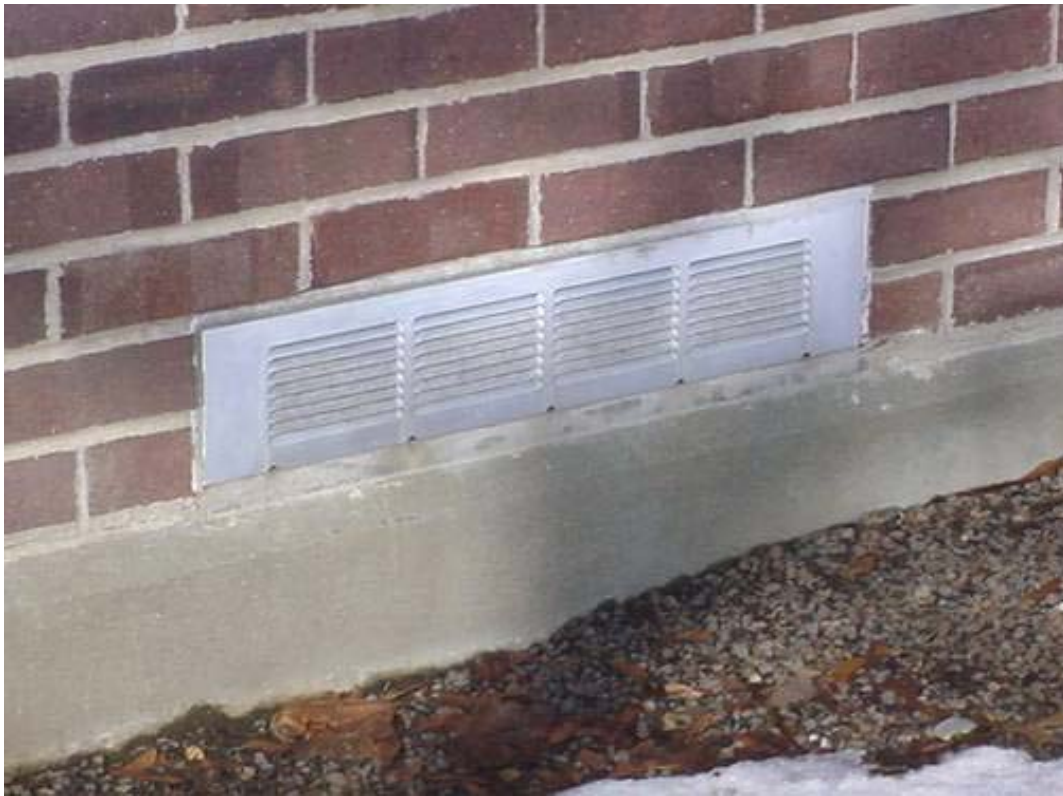
**Picture 11**

**Univent Fresh Air Intake**

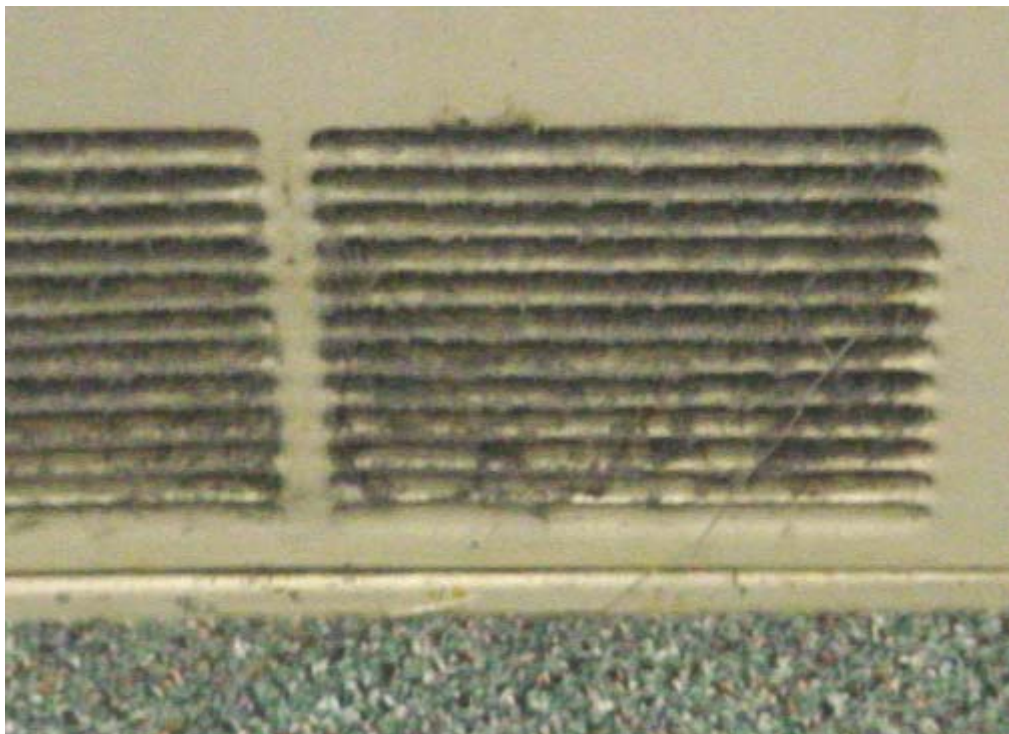
**Picture 12**

A number of univent return vents and personal fans (Pictures 12 and 19) were observed to have accumulated dust. If univents are not functioning, backdrafting can occur, which can re-aerosolize accumulated dust particles. Re-activated fans can also aerosolize dust accumulated on

**Univent Return Vent, Note Dust/Debris Accumulation**

11. Clean personal fans, univent return vents and general exhaust/return vents periodically of accumulated dust.
12. Consider relocating photocopier or thermostat in Juvenile Court if temperature control is affected.
13. Refer to resource manual and other related indoor air quality documents located on the MDPH's website for further building-wide evaluations and advice on maintaining public buildings. These documents are available at:  
<http://www.state.ma.us/dph/MDPH/iaq/iaqhome.htm>.

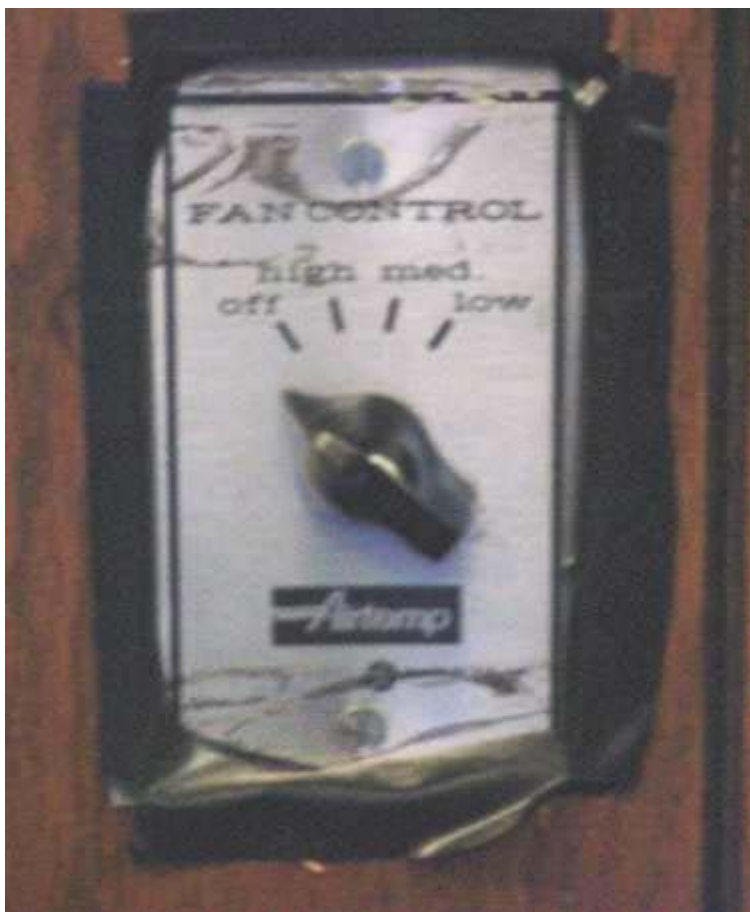
**Picture 13**

diffuser located in the top of the unit ([Figure 1](#)). Univents have control settings of off, low, med or high (Picture 13). The majority of univents were found deactivated; therefore, there was no means for providing mechanical ventilation in these areas at the time of the assessment.

**Univent Fan Controls, Note Control in “Off” Position**

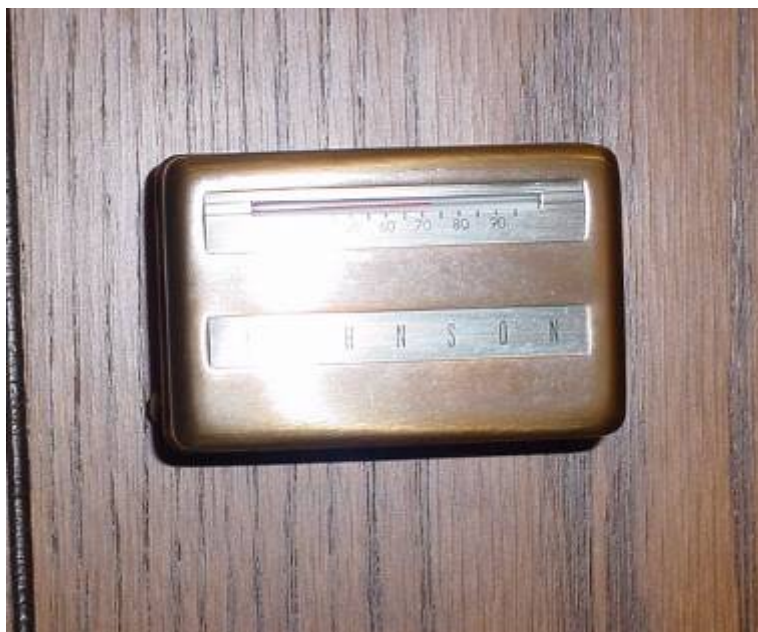
**Picture 14**

Airflow is also limited by the univent/thermostat controls. Univents at the MDC do not run continuously but are activated by thermostats (Picture 14). Univents are activated once room temperatures drop below a level set. When the room temperature exceeds the thermostat setting, the univent is deactivated or cycles off, which prevents continuous air circulation and filtration.

**Vintage 1960s Thermostat for Univent System**

thermostatic controls. If not examine the feasibility of upgrading the control system to provide continuous air exchange.

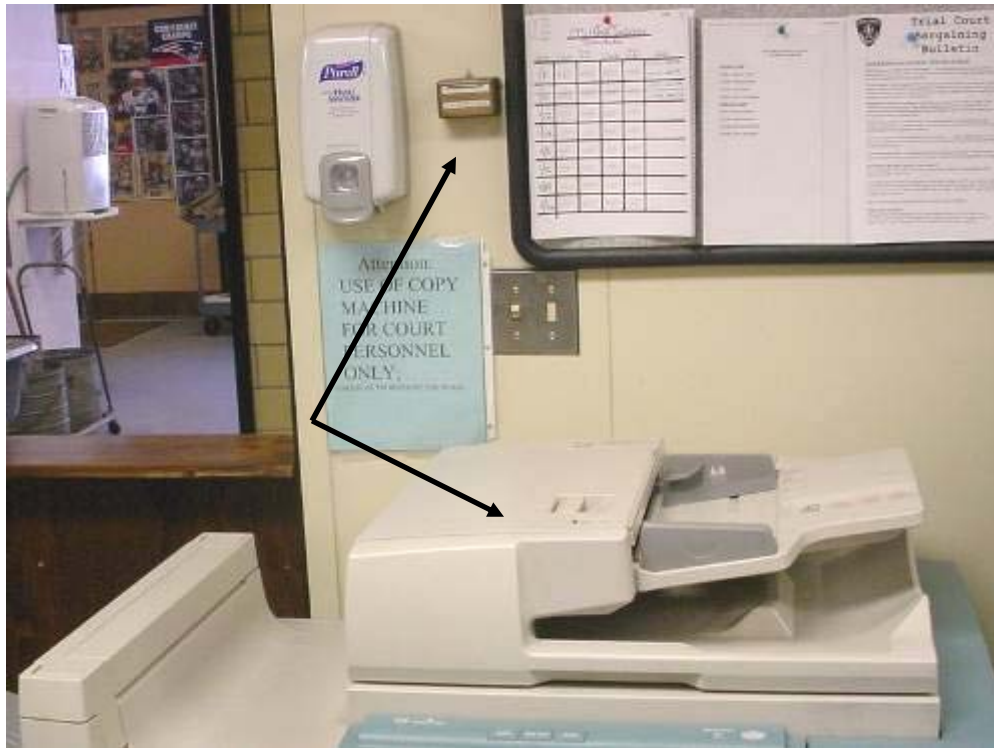
**Picture 15**

Although temperature control complaints were not expressed in the juvenile court, the potential exists. BEH staff observed a photocopier located directly beneath the thermostat (Picture 15). During summer months, heated air rising from the photocopier would activate the thermostat, which would in turn activate the HVAC system to provide cold air to this area. In winter, the HVAC system would be deactivated by heated air from the laser printer interacting with the sensors in the thermostat.

**Thermostat Directly over Photocopier**

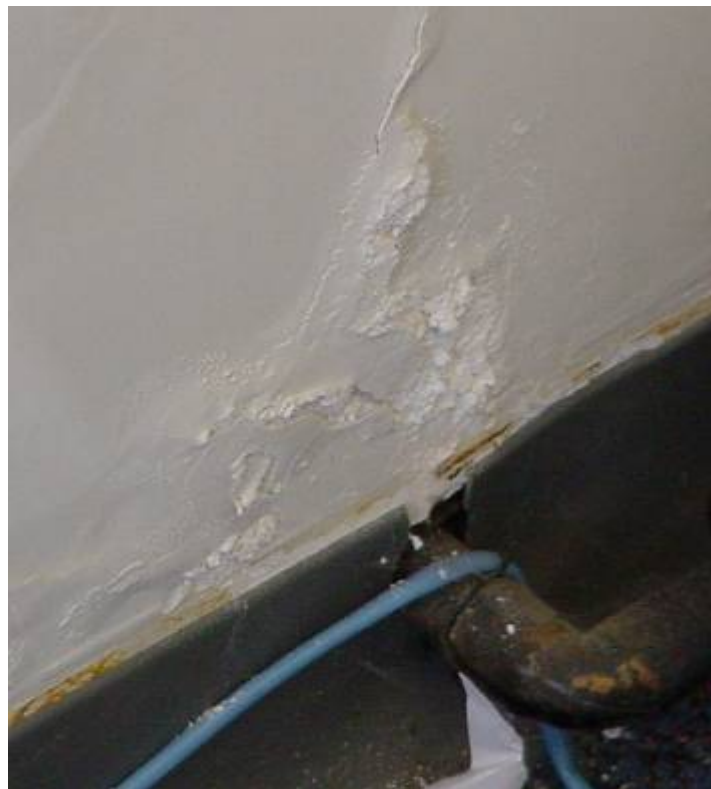
**Picture 16**

In order for building materials to support mold growth, a source of water exposure is necessary. Identification and elimination of the source of water moistening building materials is necessary to control mold growth. Water-damaged wall plaster and efflorescence (e.g., mineral deposits) was observed in April's office/D.A. area (Picture 16). As moisture penetrates and works its way through mortar around brick it leaves behind these characteristic mineral deposits. BEH staff conducted moisture testing to determine if the material was wet. Materials with increased moisture content *over normal* concentrations may indicate the possible presence of mold growth. The water-damaged wall plaster tested during the assessment was found to have low (i.e., normal) moisture content. Moisture content of materials measured is a real-time measurement of the conditions present at the time of the assessment.

**Water Damaged Wall Plaster**

8. Ensure leaks are repaired (e.g., April's office/Juvenile Court Magistrate's Office). Remove/replace water-damaged ceiling tiles. Examine the areas above and around for mold growth. Make repairs to damaged wall plaster/peeling paint.

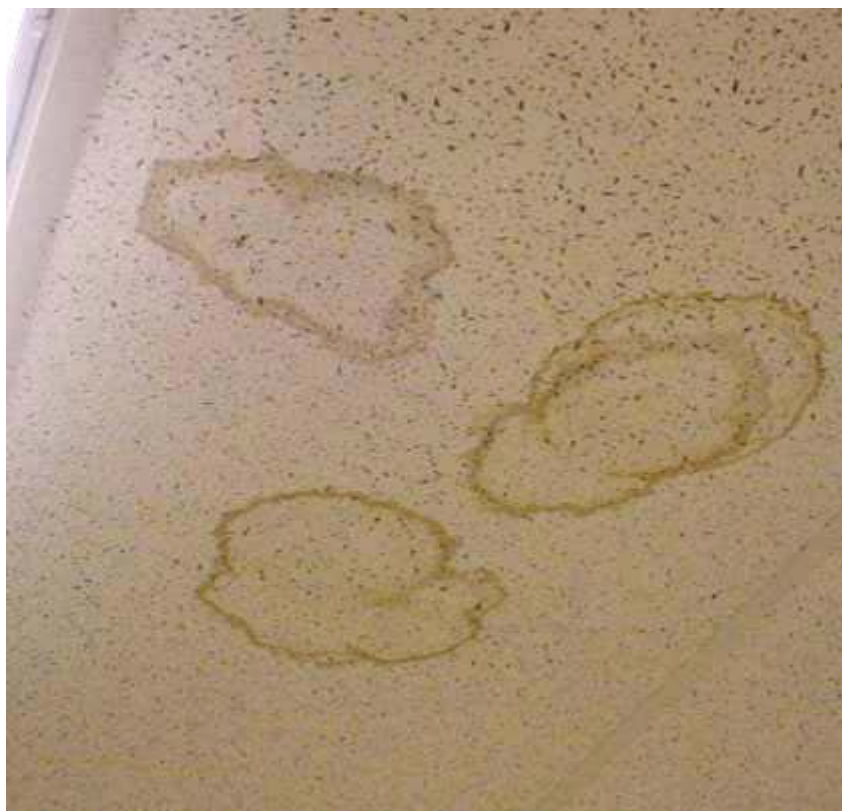
**Picture 17**

Water-damaged ceiling tiles were observed in the Juvenile Court Magistrate's office (Picture 17), which can indicate leaks from the plumbing/HVAC system. Water-damaged ceiling tiles can provide a source of mold and should be replaced after a water leak is discovered and repaired.

**Water Stained Ceiling Tiles in Juvenile Court Magistrate Area**

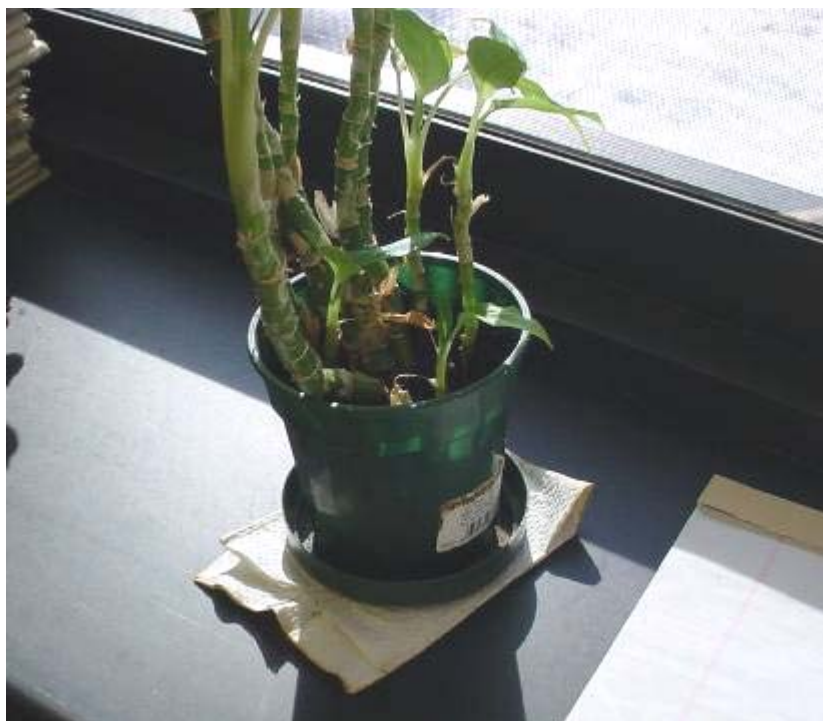
**Picture 18**

to prevent aerosolization of dirt, pollen or mold. Plants should not be placed on porous materials (Picture 18), since water damage to porous materials may lead to microbial growth.

**Plant on Paper Towel**

9. Move plants away from univents. Ensure plants are equipped with drip pans made of a non-porous material. Avoid over-watering and examine drip pans periodically for mold growth. Disinfect with an appropriate antimicrobial where necessary.

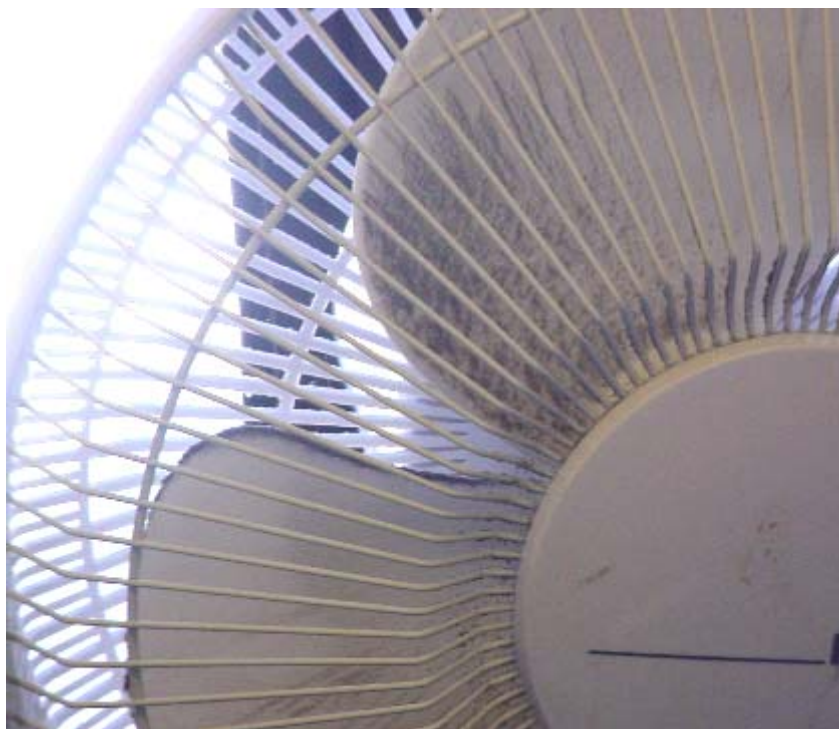
**Picture 19**

**Personal Fan with Accumulated Dust and Debris**

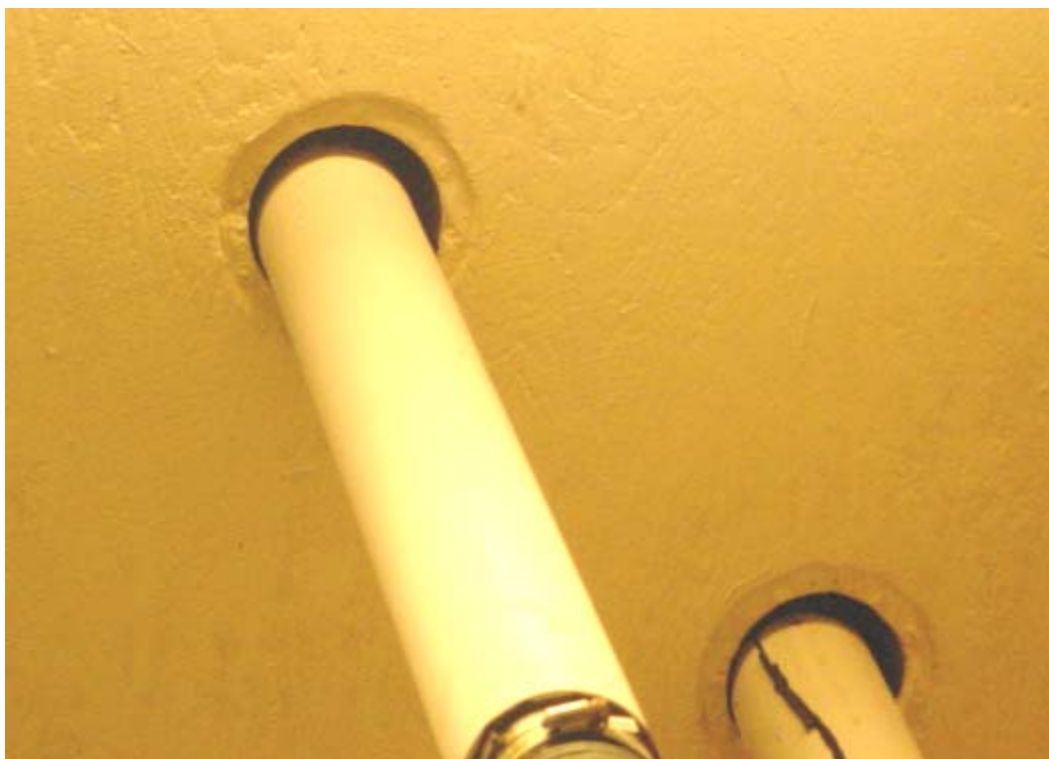
**Picture 20**

fan blades. Finally, open utility holes were observed in the ceiling of the Clerk's storeroom, which can serve as pathways for drafts, dust and debris into occupied areas (Picture 20).

**Open Utility Holes around Pipes in the Clerk's Storeroom**

10. Seal around utility pipes in ceiling of Clerk's storeroom (Picture 20).
